Repairing and Rebuilding Cockpit Windows

Kerry Pinkerton

GMCMI Chippewa Falls Wisconsin

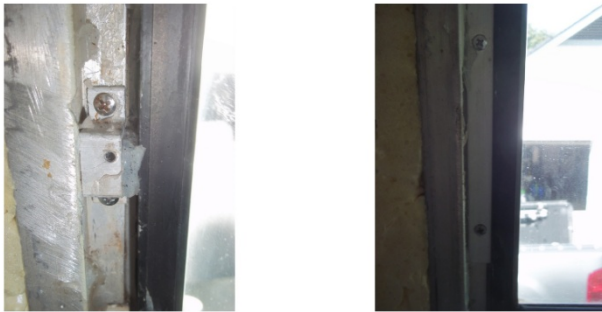
These trim clips are screwed to the window through the body. There are three of these little 'hat' clips and a strip with two screws each on the back.

Note the silicone...lots and lots of silicone. From the multitude of holes in the Fiberglass, it was obvious my window had been removed at least once before.

Across the top and bottom are 1/2x 12-14" strips with three screws each. Some of these screws did NOT want to come out and a couple had to be drilled out.

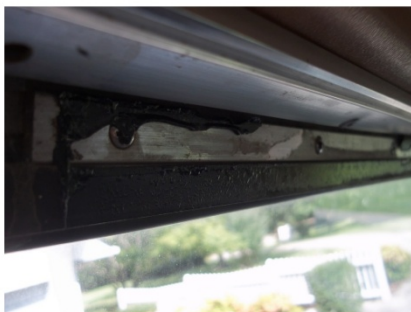
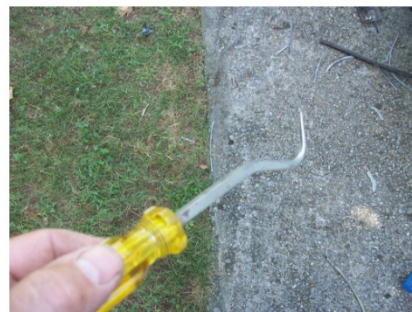
This pick was indispensable in digging out all the old sealant and silicone. INDISPENSIBLE!

Once all the screws were out, the window would not move. I pushed, and pulled, and pried, and tapped, and finally got out the 3 lb sledge and a block of wood and CAREFULLY whacked the heck out of it. NOTHING! ((*&#\$\$@

I had to make another tool in order to get some leverage. It's just a midsize screwdriver that I heated with a torch and bent an 90 degree angle so I could use it as a mini pry bar. FINALLY it came loose at the back and I was able to wiggle it out of the 'A' Pillar channel. There wasn't much in the way of gasket material or sealant but what was there was tenacious.

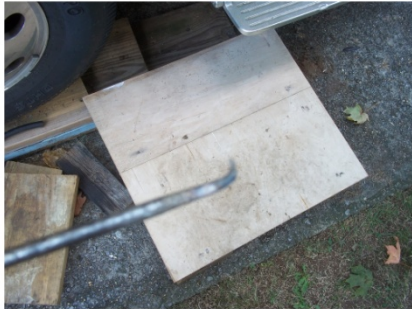
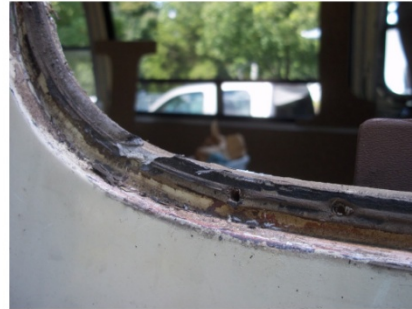
It was pretty obvious why the window leaked. All the old sealant was in terrible shape.

Some photos of the condition of the channel and whatever this stuff was in the A pillar channel???

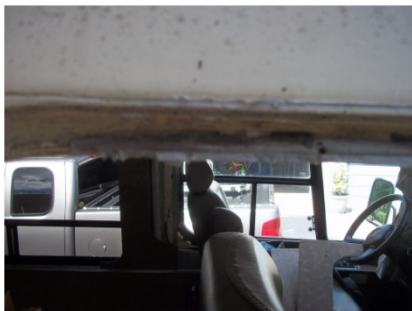
More shots of the nasty openings.

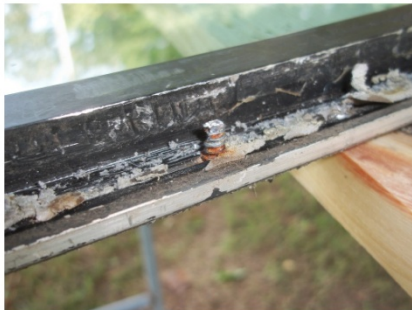
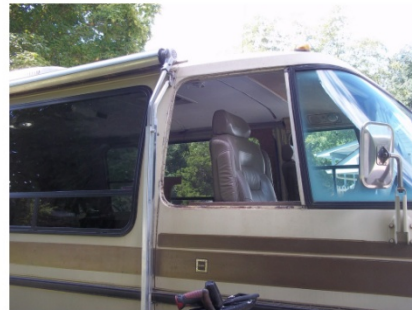
And THIS is why the dang thing wouldn't come out. An old broken screw was still in the window frame and the Fiberglas opening. So I cleaned up the opening in the coach with a wire brush, my handy little pick to dig out all the nooks and crannies and finally wiped it down with acetone. I did that until it was as clean as I could make it.

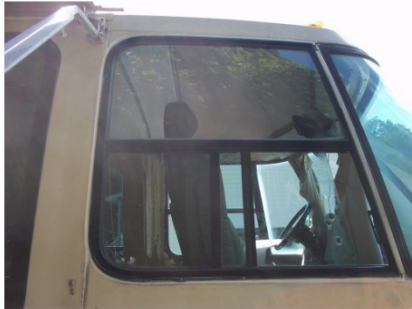
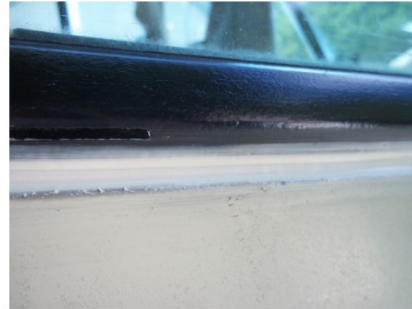
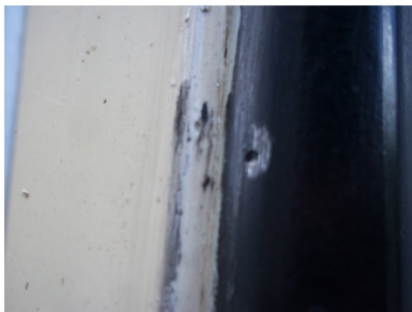
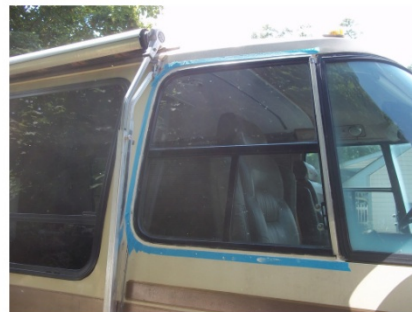
I STRONGLY recommend not doing this alone. I did and regret it. The problem is that there are already holes in the window frame AND the cockpit frame. If you have help, you can position the window so you can reuse those holes. I didn't and had to redrill them, a royal pain and something I won't repeat on the drivers side.

Another thing I did that I do not recommend is the sealant I used. It was the best SEALANT that Lowes had but if I had it to do again, I'd have just used the Butyl tape that is used to install the new windows, fantastic fans, etc. It is great stuff and seals like a ...well...like it's supposed to. The stuff I used will probably work fine but it did not finish as cleanly as I'd have hoped. If I'd have had more time, I'd have taken it out and redone it with the Butyl, then just calked with paintable silconized latex or similar.
